Chaff, Flares and CADs Can Kill

By George Alston

The ALE-39 and ALE-47 countermeasures dispensers have saved many lives and aircraft. This same system can be deadly when maintenance technicians fail to follow safety procedures found in the maintenance manuals.

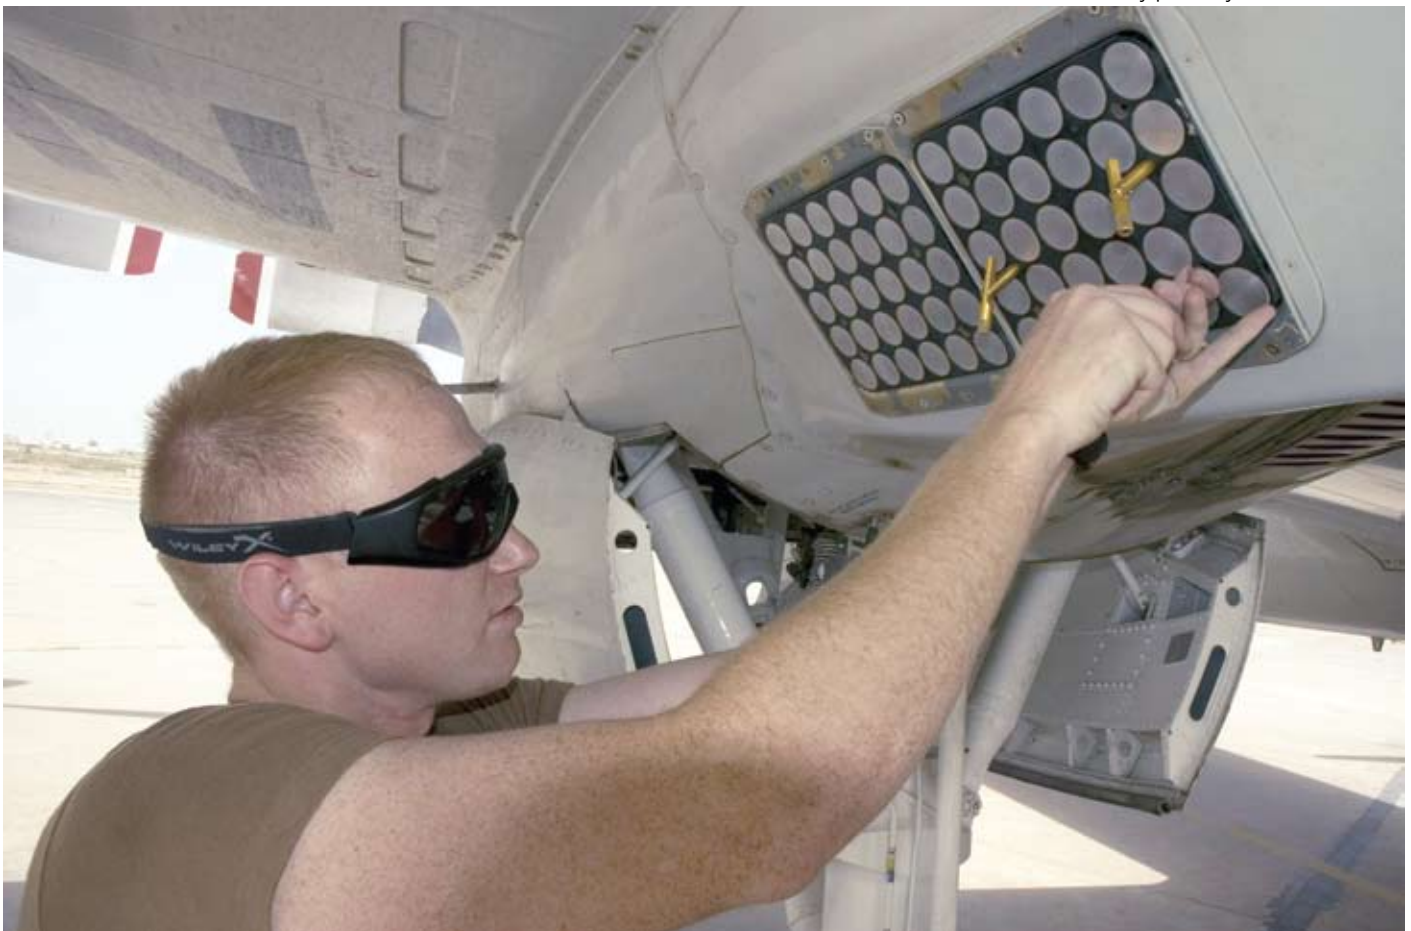
Navy photo by MC1 Eric Benson

AO3 Cary Buel installs a MJU-49/B Decoy Flare bucket into the ALE-47 Counter Measure Dispensing system on a P-3C Orion assigned to VP-9. The Counter Measure Dispensing system is vital to the survivability of the P-3C by enabling the crew to dispense chaff and flares in defense of enemy fire.
